**TECHNICAL REPORT 92-3**

**IN-SERVICE PERFORMANCE OF  
EPOXY-COATED STEEL REINFORCEMENT  
IN BRIDGE DECKS**

**JUNE 1992**

**NEW YORK STATE DEPARTMENT OF TRANSPORTATION**  
MARIO M. CUOMO, Governor  
FRANKLIN E. WHITE, Commissioner

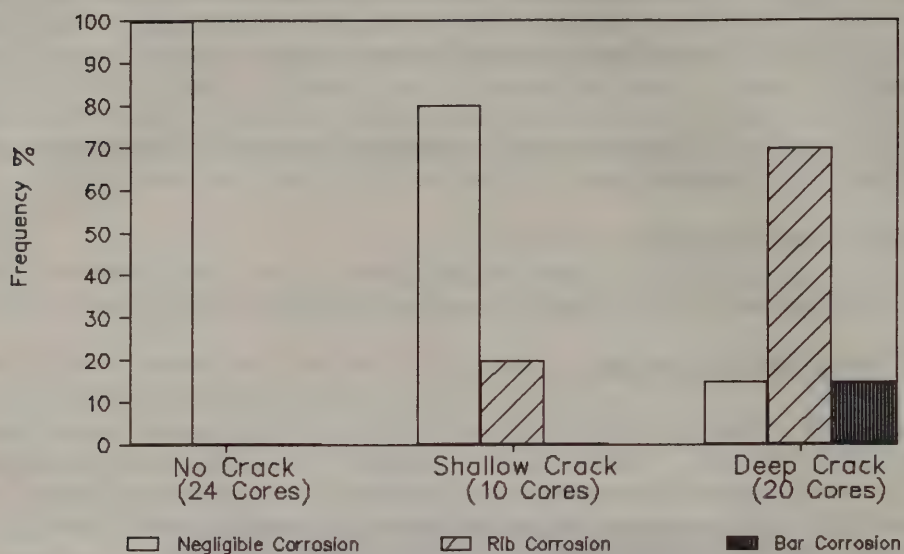
Figure 1 shows the apparent influence of cracks on corrosion. No bars from the 24 cores with no cracks had significant corrosion. Of the 10 cores with shallow cracks, 80% had negligible corrosion and 20% had rib corrosion. No cores in this group had bar corrosion. Of the 20 cores with deep cracks, 15% had negligible corrosion, 70% rib corrosion, and the remaining 15% bar corrosion. Figure 1 suggests that corrosion is more likely to occur and be more extensive if the concrete cover protecting the steel is cracked.

**FIGURE 1. CORROSION ACTIVITY ON EPOXY-COATED REBARS IS GREATER WITH DECK CRACK SEVERITY**

The survey did find greater corrosion activity on epoxy-coated steel reinforcement at locations where the bridge deck surface was cracked. The protective epoxy coating appeared to not perform as well under these conditions. The significance of cracks in the bridge deck, and their relation to corrosion on epoxy-coated steel reinforcement, warrant more study.
